**SITE INSPECTION REPORT  
THE CLOROX COMPANY OF PR  
CAGUAS, PUERTO RICO**

CERCLIS ID No.: PRD090473398

August 10, 2006

**PUERTO RICO ENVIRONMENTAL QUALITY BOARD  
EMERGENCY RESPONSE AND SUPERFUND PROGRAM  
SUPERFUND PA/SI DIVISION  
SAN JUAN, PUERTO RICO 00926**

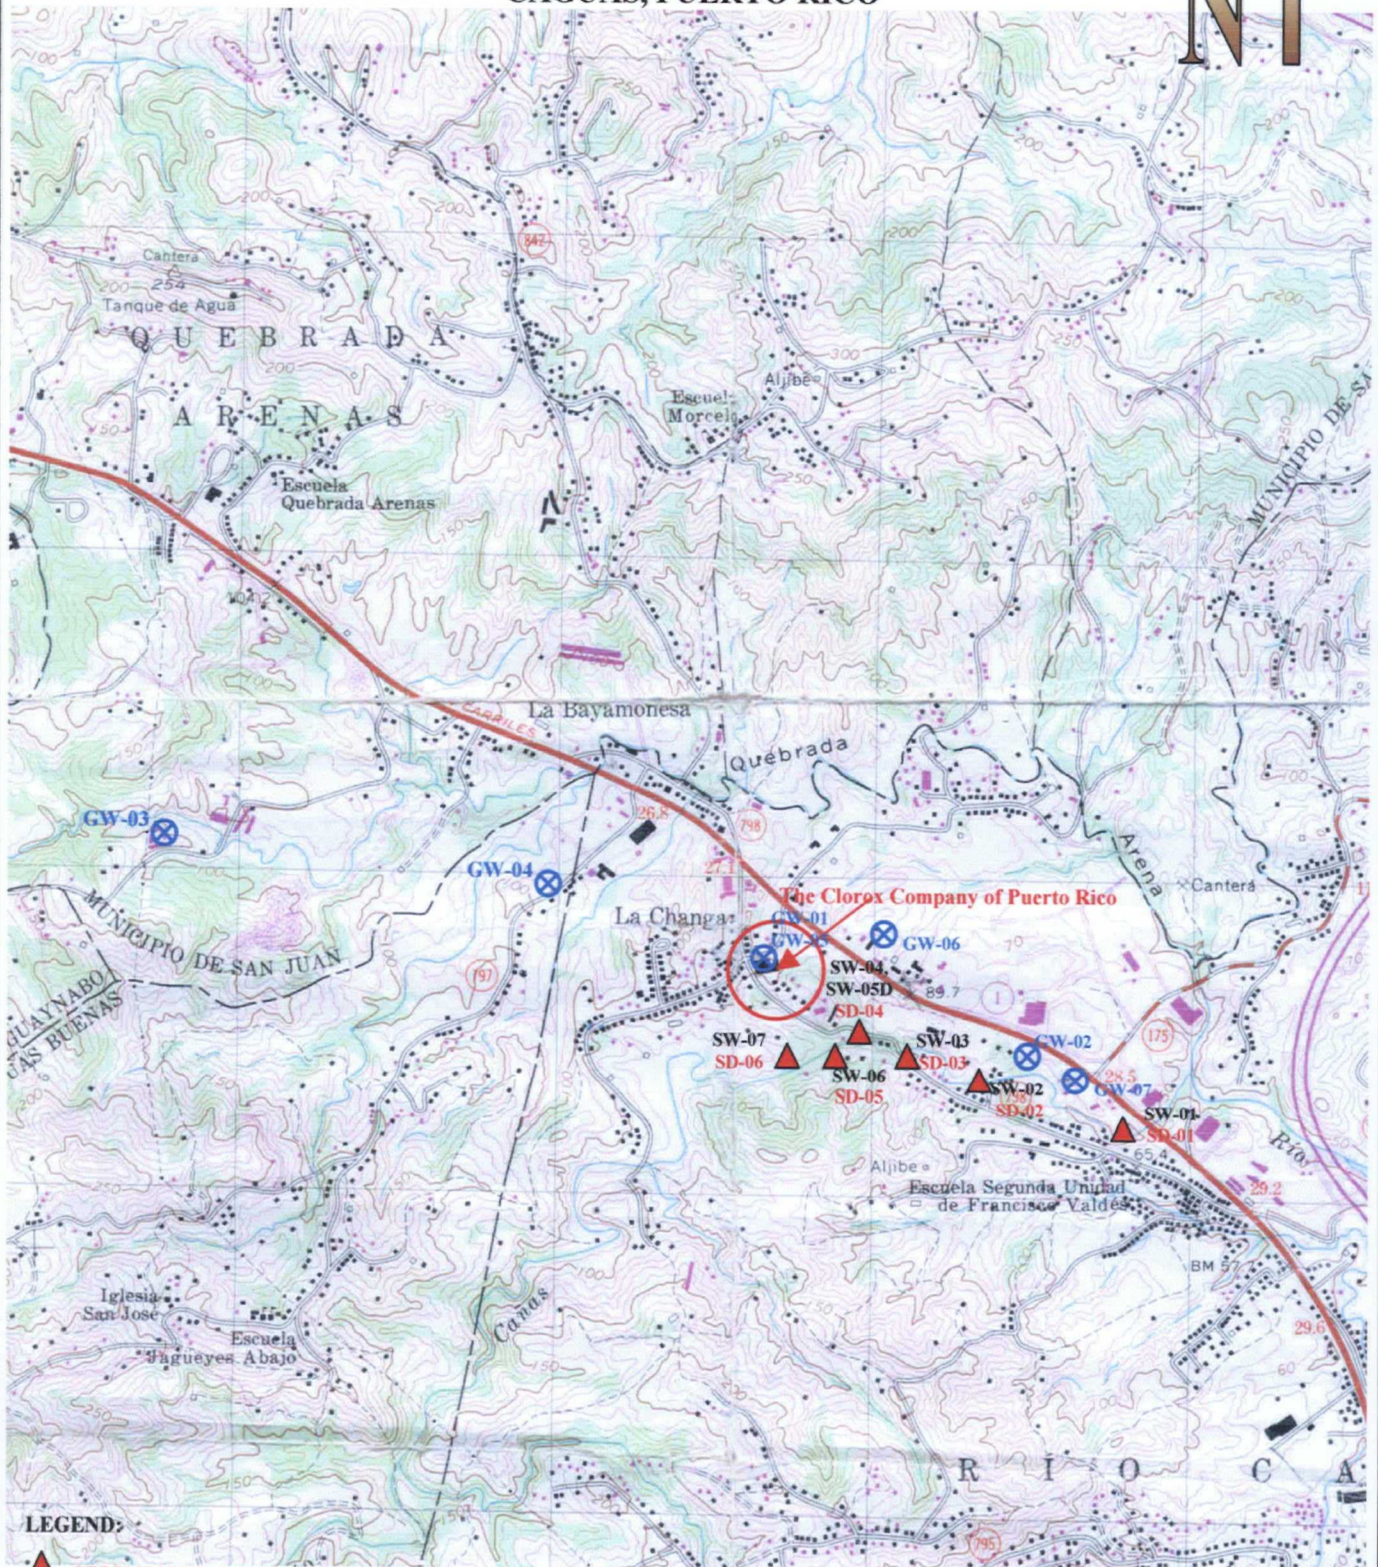
**FIGURE 5**

The results indicated the presence of Aroclor-1260 at concentrations of **180 µg/mg in sediment sample** (SD-04) collected at the PPE #2 (See Figure 3). This contaminant was found in one of the surface soil samples collected during the sampling activities performed from March 7-14, 2006.
